# Diagnostics of photovoltaic power plants operation

**Vitezslav Benda,**  
CTU Prague, Faculty of Electrical Engineering

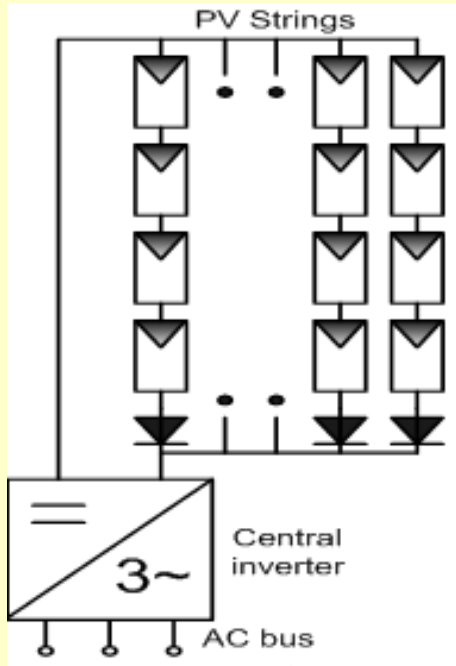
## Central inverters

- 10 kW-250kW, three-phase, several strings in parallel
- High efficiency, low cost, low reliability, not optimal MPPT
- Used for power plants

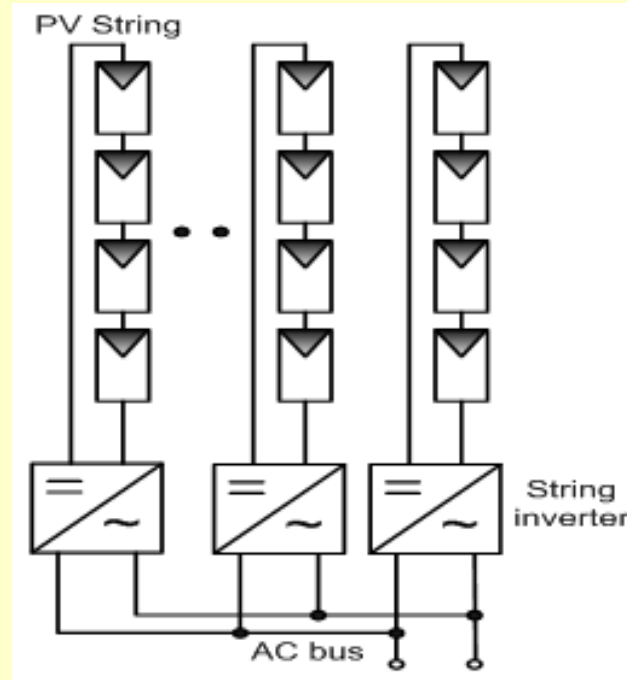
## String (Multi)inverters

- 1.5-5 kW, typical residential application
- Each string has its own inverter enabling better MPPT
- The strings can have different orientations
- Three-phase inverters for power < 5kW

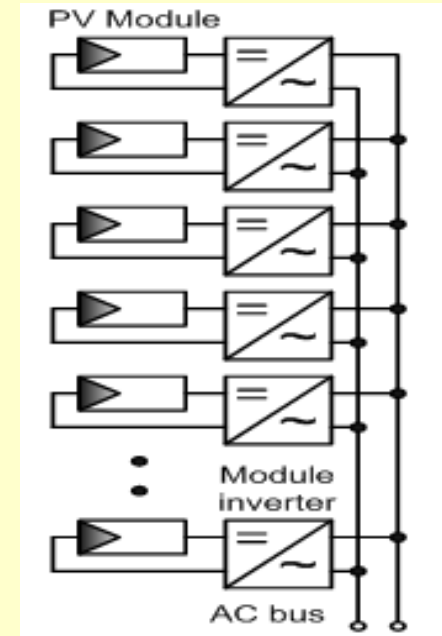
## Module inverters

- 50-180W, each panel has its own inverter enabling optimal MPPT
- Lower efficiency, difficult maintenance
- Higher cost/kWp

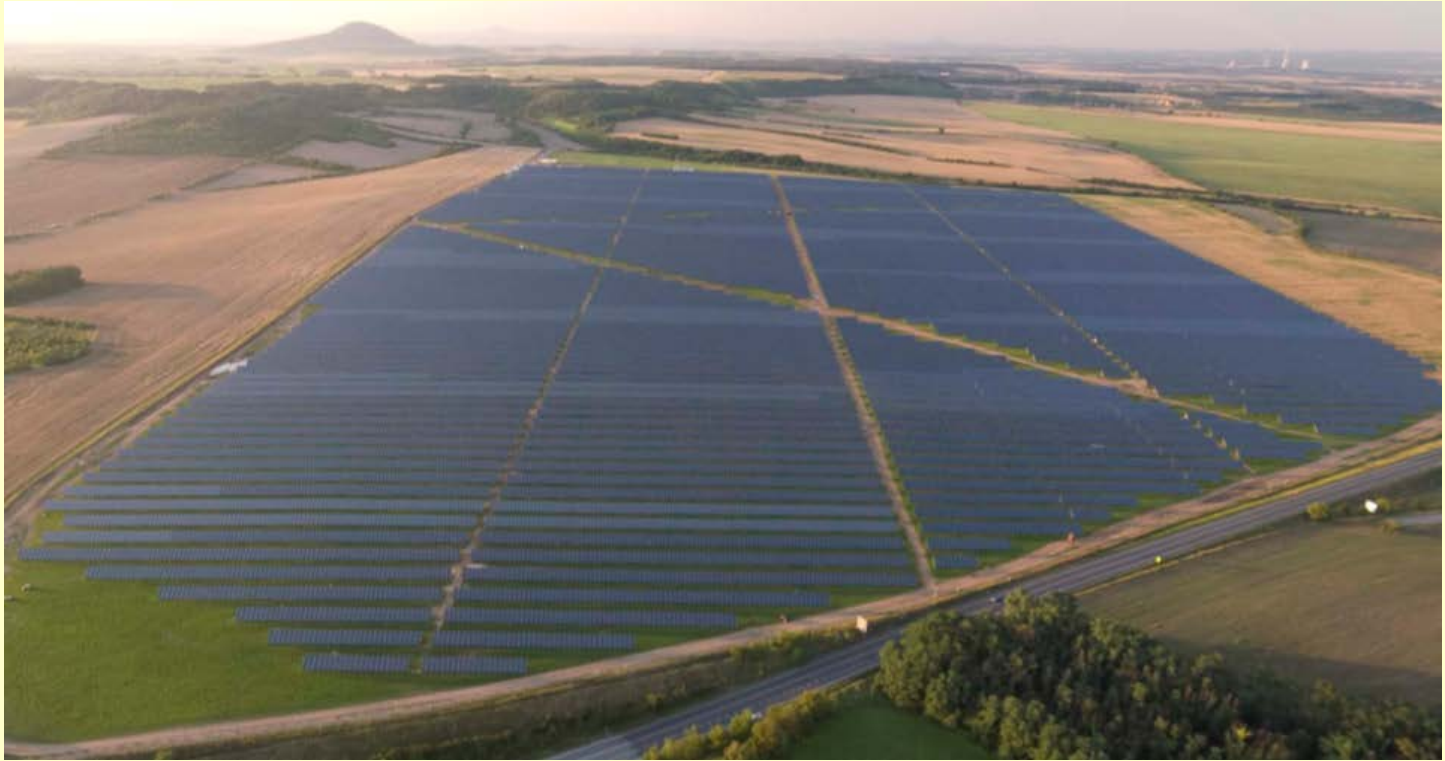
## 35 MW<sub>p</sub> power station in Veprek (20 km from Prague)

- 186 960 panels rated at 185W<sub>p</sub> and 190W<sub>p</sub> each (Phonosolar)
- 3300 SMA 10 kW and 11 kW inverters using a (multi)string configuration
- 26 transformers from 0.4kV to 22kV
- 1 transformer connects the total generated power to the 110 kV high voltage power line

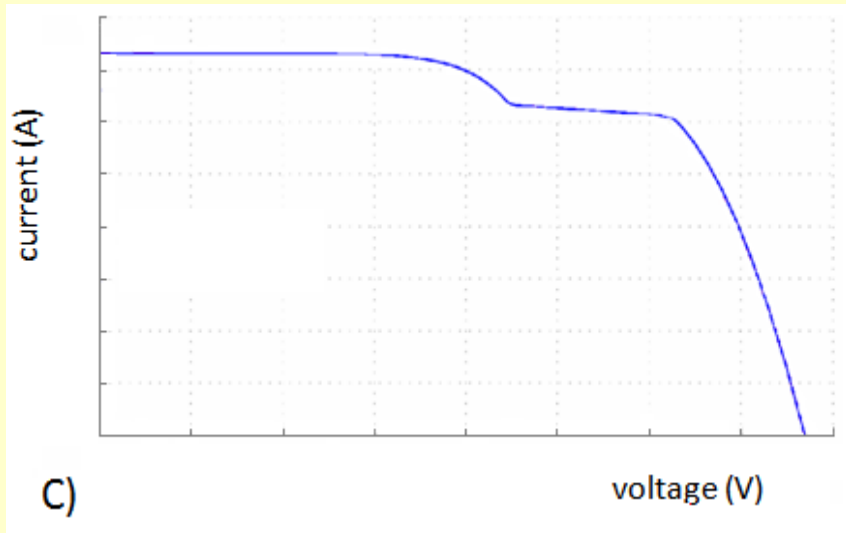
C) Cracked or partially shaded cell

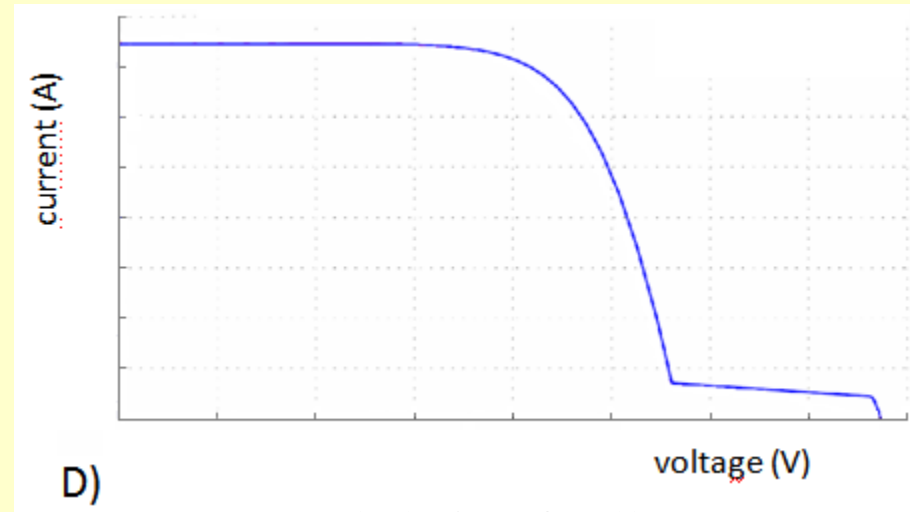
D) Interrupted chain of cells or completely shaded cell
